**TEST REPORT No. 367962**

**glazed railing without handrail named "M3"**

**resistance to horizontal linear static loading  
and dynamic loading in accordance with  
standard UNI 11678:2017/EC-1 2017**

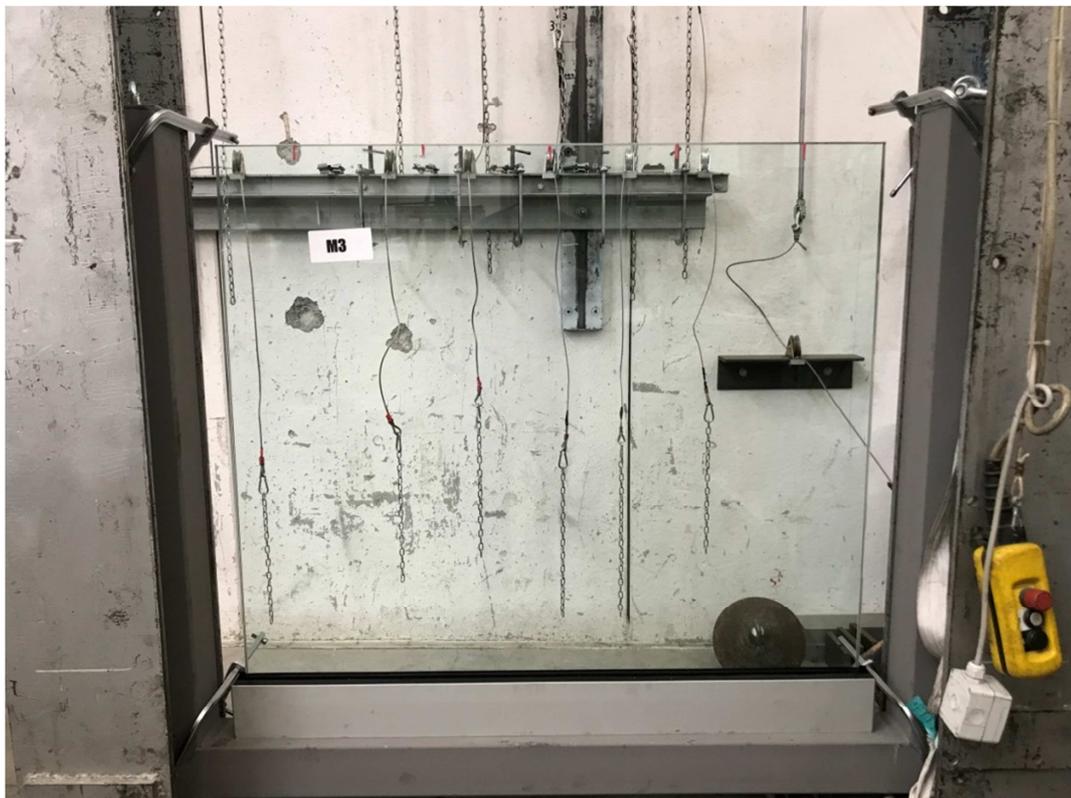
### Item photograph

The item consists of a glass/aluminum railing without handrail with the characteristics reported in the following table.

The glass type is laminated glass, overall nominal thickness 21,52 mm, made of:

- 10 mm tempered glass;
- 1,52 mm PVB;
- 10 mm tempered glass.

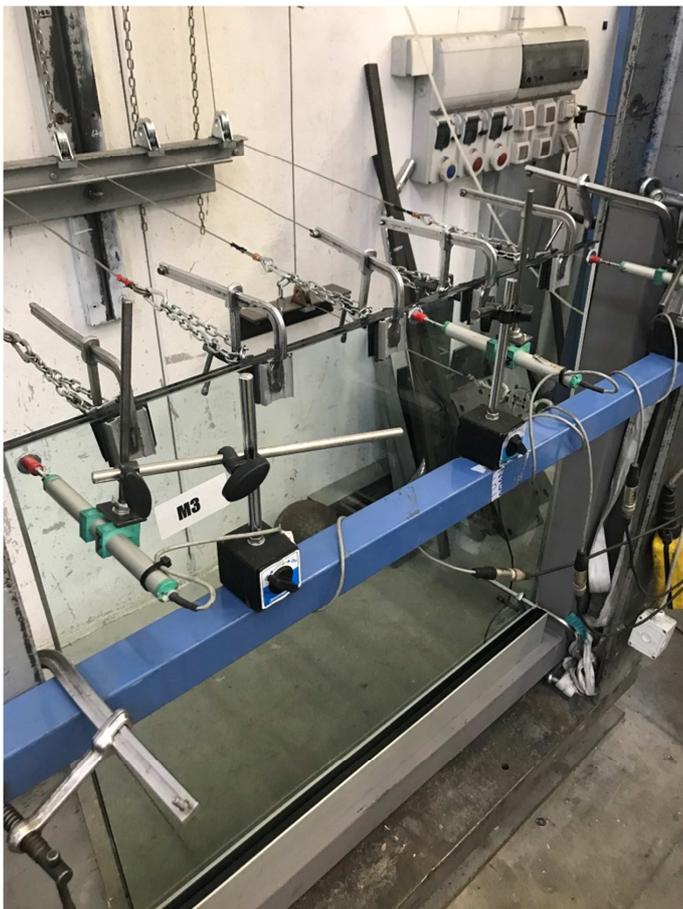
Photograph of the railing subjected to working load

Load step	Load [kN/m]	Duration [min]	Deflection at the measuring points			Maximum allowed deformation [mm]	Effect
			A [mm]	B [mm]	C [mm]		
preload	0,5	5	//	//	//	//	no damage
working load	1,0	5	39,5	40,0	39,6	≤100	no damage
load removal	0,0	//	6,8	6,8	6,7	≤10	//
ultimate load	1,5	5	//	//	//	//	no damage
breakage of internal glass pane							
collapse load after glass pane breakage	0,3	1	//	//	//	//	no collapse

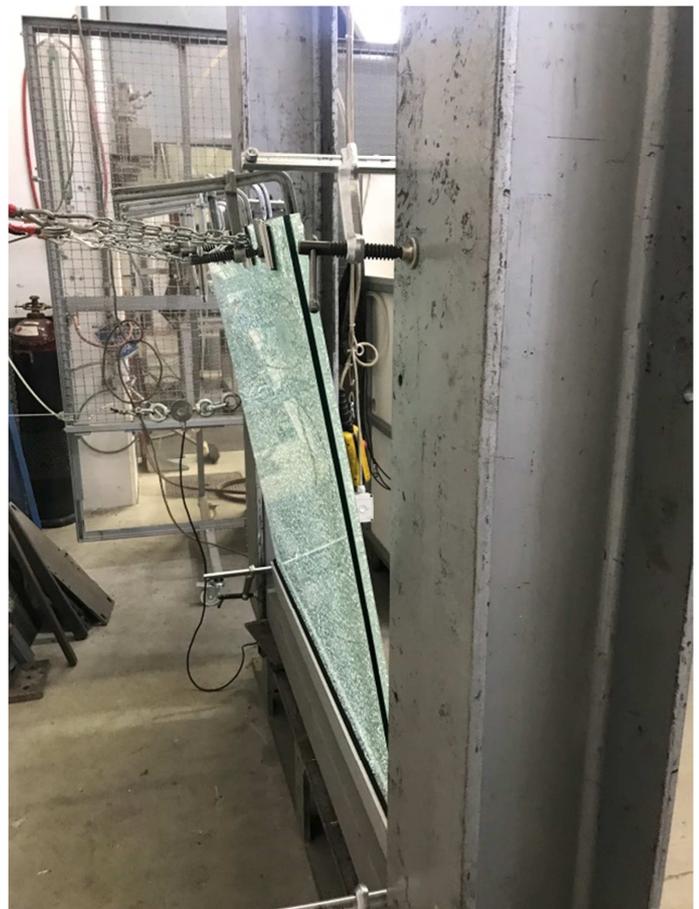
Photograph of the railing after breakage

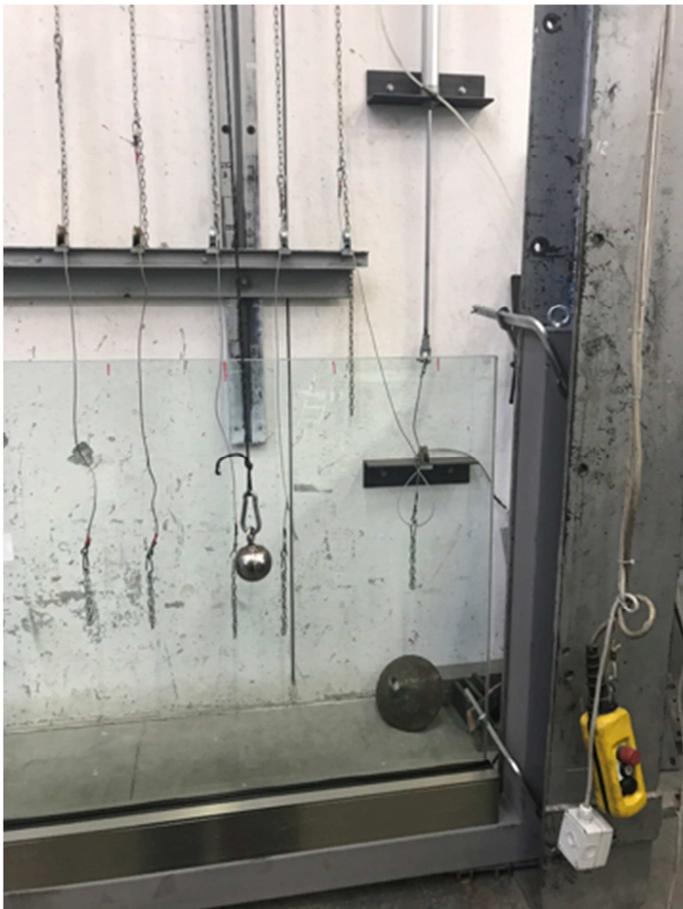
**Photograph of the railing after hard body impact**

Impact type	Impact area	Drop height [mm]	Impact energy [J]	Effect
hard body	along the median 100 mm from the upper edge	1020	10	no damage
	at infill centre	1020	10	no damage
	near to a fixing point	1020	10	no damage
double-tire body	100 mm from top edge	700	350	no damage
	at infill centre	700	350	no damage
	250 mm from the corner along the bisectors	700	350	no damage

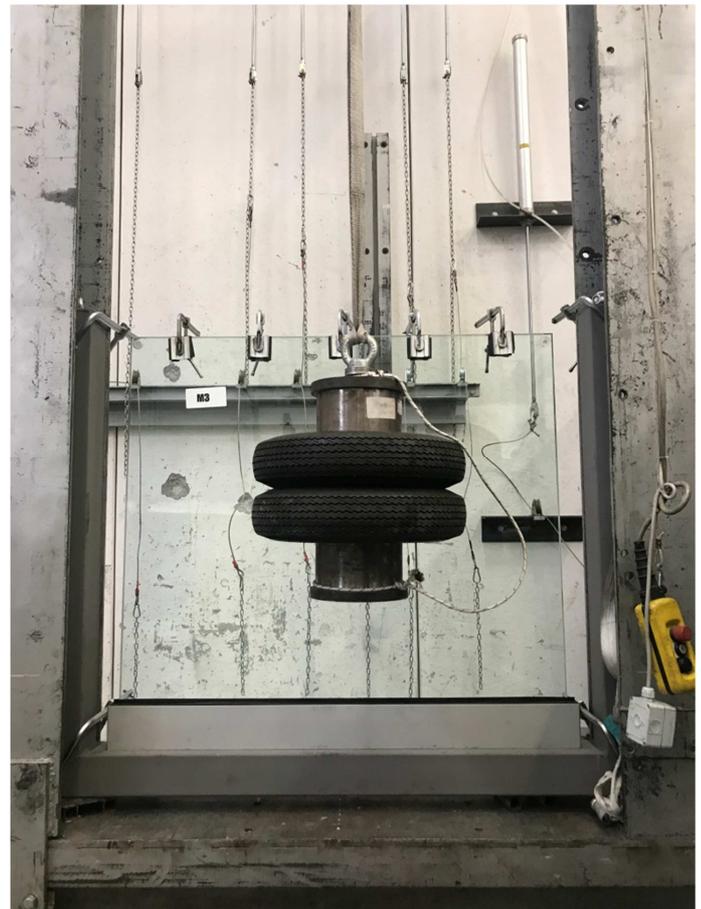
**Photograph of the railing after double-tire body impact**
